U.S. Department
of Transportation
**Federal Highway
Administration**

- SafeZone MASH TL-4 Limited Deflection

Summary of Crash Test Results

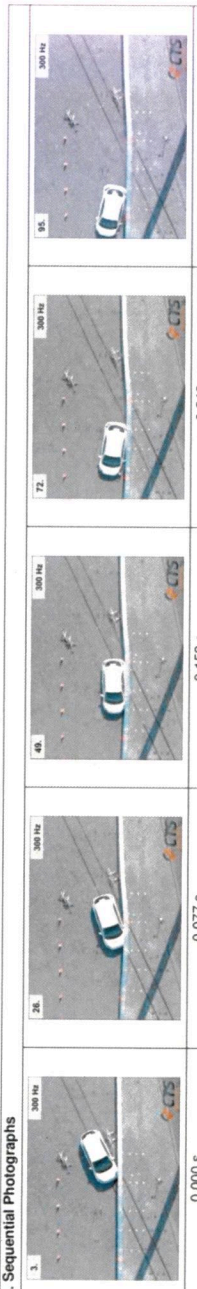
| 1. Sequential Photographs | | | | | 3. Cross-Sectional View | | | | |
| 4. General Information Test Agency: crashtest-service.com GmbH (CTS) Test Standard: MASH Test TL4-10 CTS-Test No.: 18648 Date: April 20, 2017 5. Test Article Type: Barrier Name: SafeZone Installation Length: 40.62 m (133.27 ft) Key Elements - Barrier: Length: 5.80 m (18.99 ft), Base Width: 0.45 m (1.48 ft), Height: 0.81 m (2.66 ft) | | | | | 8. Impact Conditions Speed: 102.1 km/h (63.4 mph) Angle: 25 degrees Location/Orientation: m (41.7 in) before transition of elements III & IV 9. Exit Conditions Speed: 84 km/h (52 mph) Angle: 12 degrees 10. Post-Impact Trajectory Vehicle Stability: Satisfactory Stopping Distance: 42.90 m (140.73 in) downstream, 9.40 m (30.84 in) laterally in front Vehicle Snagging: None Vehicle Pocketing: None 11. Occupant Risk Impact Velocity: Longitudinal 4.72 m/s (15.49 ft/s), Lateral 7.22 m/s (23.69 ft/s) Ridedown Accelerations (10 msec avg.): Longitudinal -5.37 g, Lateral -14.73 g | | | | |

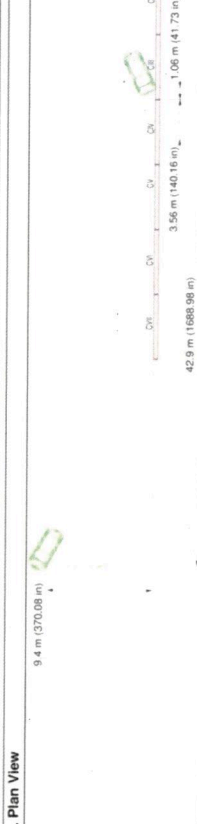
| 2. Plan View | | | | | | | | | |
