In Reply Refer To: HSST-1 / B-308

• HV2 Barrier

# Request for Federal Aid Reimbursement Eligibility of Highway Safety Hardware

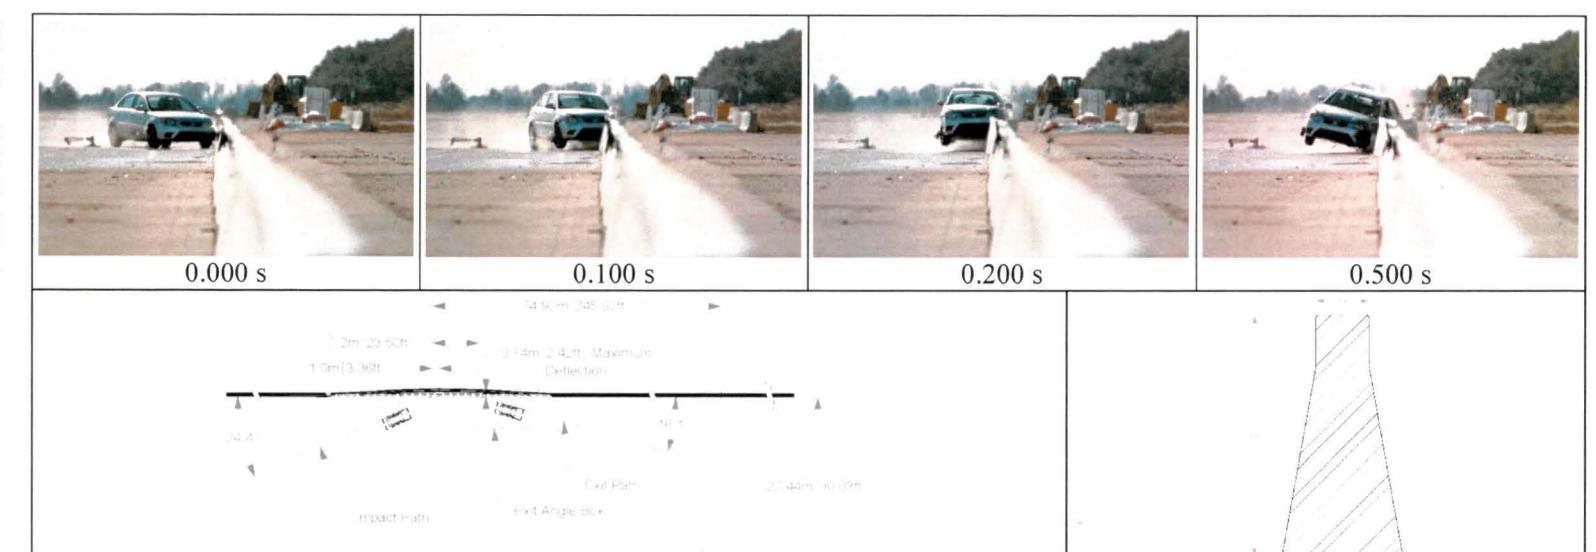
Figure 5.6. Summary of Results for MASH Test 4-10 on HV2 Barrier.

General Information		Impact Conditions	Post-Impact Trajectory	
Test Agency	Texas A&M Transportation Institute (TTI)	Speed	Stopping Distance	75 m (246 ft) dwnstrm
Test Standard Test No	MASH Test 4-10	Angle		27 m (90 ft) twd traffic
TTI Test No.	690902-SFR7	Location/Orientation 1.03 m (3.36 ft)	Vehicle Stability	
Test Date	2017-01-04	upstream of joint 24-25	Maximum Yaw Angle	48°
Test Article		Impact Severity	Maximum Pitch Angle	4°
Туре	Portable Barrier	Exit Conditions	Maximum Roll Angle	15°
Name	HV2 Barrier	Speed75.7 km/h (47.0 mi/h)	Vehicle Snagging	Slight
Installation Length	278.4 m (913.4 ft)	Angle	Vehicle Pocketing	No
Material or Key Elements	48 barrier units, each 5.8 m (19 ft-3/s inch)	Occupant Risk Values	Test Article Deflections	
	in length, connected with proprietary dual	Longitudinal OIV 5.2 m/s (17.1 ft/s)	Dynamic	0.75 m (2.45 ft)
	finger-and-knuckle connector welded into	Lateral OIV 6.2 m/s (20.3 ft/s)	Permanent	0.74 m (2.42 ft)

the ends	Longitudinal Ridedown 4.8 g	Working Width	1.05 m (3.45 ft)
Soil Type and Condition	Concrete Pavement, Damp	Lateral Ridedown7.9 g	Height of Working Width	0.90 m (2.95 ft)
Test Vehicle		THIV	Vehicle Damage	
Type/Designation	1100C	PHD8.8 g	VDS	11LFQ5
Make and Model	2010 Kia Rio	ASI1.78	CDC	11FLEW4
Curb	1128 kg (2486 lb)	Max. 0.050-s Average	Max. Exterior Deformation	203 mm (8.0 inches)
Test Inertial	1102 kg (2430 lb)	Longitudinal10.3 g	OCDI	LF0020000
Dummy	75 kg (165 lb)	Lateral 13.0 g	Max. Occupant Compartment	
Gross Static	1177 kg (2595 lb)	Vertical3.8 g	Deformation	102 mm (4.0 inches)

Required Test	Narrative	Evaluation
Number	Description	Results
4-10 (1100C)	MASH 4-10 (TTI) Test No. 690902-SFR7 Test Date - January 4th, 2018 Test Report No. 690902-SFR6,7&8 The test installation comprised of 48 connected, freestanding HV2 barriers, each 5.8m (19ft-3/8inch) long, totaling 278.4m (913ft-4.63inches). The 1,102kg (2,430lb) 2010 model Kia Rio was traveling at an impact speed of 99.1km/h (61.6mph) as it contacted the HV2 Barrier 1.03m (3.36ft) upstream of the joint between segments 24 and 25 at an impact angle of 24.4°. The HV2 Barrier contained and redirected the test vehicle with a Dynamic deflection of 0.75m (2.45ft). The vehicle did not penetrate, underride or override the installation. No detached elements, fragments, or other debris were present to penetrate or show potential for penetrating the occupant compartment, or to present undue hazard to others in the area. Maximum occupant compartment deformation was 102mm (4.0inches). The vehicle remained upright during and after the collision event. Maximum roll and pitch angles were 15° and 4° respectively. Occupant Risk factors were all well within the preferred limits specified in MASH.	PASS

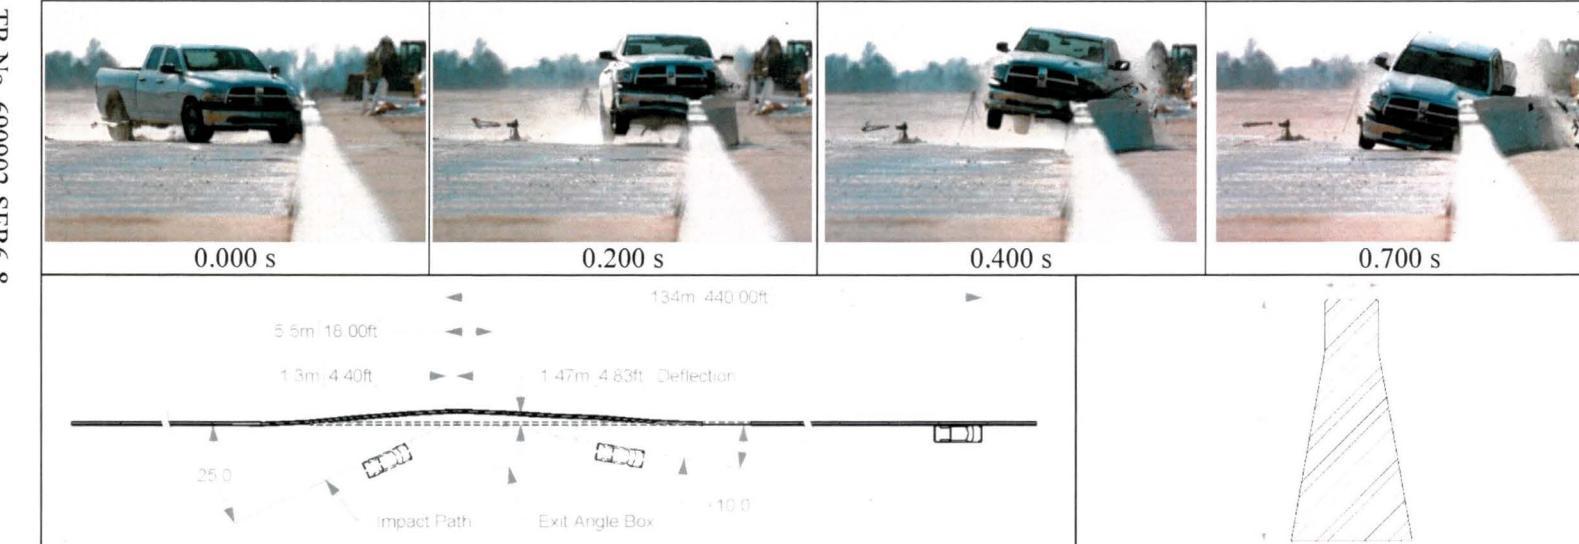
Figure 6.8. Summary of Results for MASH Test 4-11 on HV2 Barrier.

General Information		Impact Conditions	Post-Impact Trajectory
Test Agency	Texas A&M Transportation Institute (TTI)	Speed 101.5 km/h (63.1 mi/h)	Stopping Distance 134 m (440 ft)
Test Standard Test No	MASH Test 4-11	Angle	downstream
TTI Test No.	690902-SFR6	Location/Orientation 1.34 m (4.41 ft)	Vehicle Stability
Test Date	2017-01-03	upstream of joint 24-25	Maximum Yaw Angle 33°
Test Article		Impact Severity 144 kJ (106 kip-ft)	Maximum Pitch Angle 6°
Туре	Portable Barrier	Exit Conditions	Maximum Roll Angle 14°
Name	HV2 Barrier	Speed, est'd 87 km/h (54 mi/h	Vehicle Snagging Minimal
Installation Length	278.4 m (913.4 ft)	Angle, est'd Out of view (~10°)	Vehicle Pocketing No
Material or Key Elements	48 barrier units, each 5.8 mm (19 ft-3/2	Occupant Risk Values	Test Article Deflections
	inch) in length, connected with	Longitudinal OIV 4.1 m/s (13.4 ft/s)	Dynamic 1.47 m (4.83 ft)
	proprietary dual finger-and-knuckle	Lateral OIV 4.8 m/s (15.8 ft/s)	Permanent 1.47 m (4.83 ft)

connector welded into the ends	Longitudinal Ridedown 5.0 g	Working Width 1.81 m (5.94 ft)
Soil Type and Condition	Concrete Pavement, Damp	Lateral Ridedown 10.3 g	Height of Working Width 0.90 m (2.95 ft)
Test Vehicle	energy and a second	THIV	Vehicle Damage
Type/Designation	2270P	PHD 10.5 g	VDS 11LFQ5
Make and Model	2012 Dodge RAM 1500 Pickup	ASI	CDC 11FLEW4
Curb	2218 kg (4890 lb)	Max. 0.050-s Average	Max. Exterior Deformation 305 mm (12.0 inche
Test Inertial	2275 kg (5015 lb)	Longitudinal6.9 g	OCDI LF0030000
Dummy	75 kg (165 lb)	Lateral9.2 g	Max. Occupant Compartment
Gross Static	2350 kg (5180 lb)	Vertical3.8 g	Deformation 140 mm (5.5 inches

Required Test Number	Narrative Description	Evaluation Results
4-11 (2270P)	MASH 4-11 (TTI) Test No. 690902-SFR6 Test Date - January 3rd, 2018 Test Report No. 690902-SFR6,7&8 The test installation comprised of 48 connected, freestanding HV2 barriers, each 5.8m (19ft-3/8inch) long, totaling 278.4m (913ft-4.63inches). The 2,275kg (5,015lb) 2012 model Dodge Ram 1500 was traveling at an impact speed of 101.5km/h (63.1mph) as it contacted the HV2 Barrier 1.34m (4.41ft) upstream of the joint between segments 24 and 25 at an impact angle of 25°. The HV2 Barrier contained and redirected the test vehicle with a Dynamic deflection of 1.47m (4.83ft). The vehicle did not penetrate, underride or override the installation. No detached elements, fragments, or other debris were present to penetrate or show potential for penetrating the occupant compartment, or to present undue hazard to others in the area. Maximum occupant compartment deformation was 140mm (5.5inches). The vehicle remained upright during and after the collision event. Maximum roll and pitch angles were 14° and 6° respectively. Occupant Risk factors were all well within the preferred limits specified in MASH	PASS

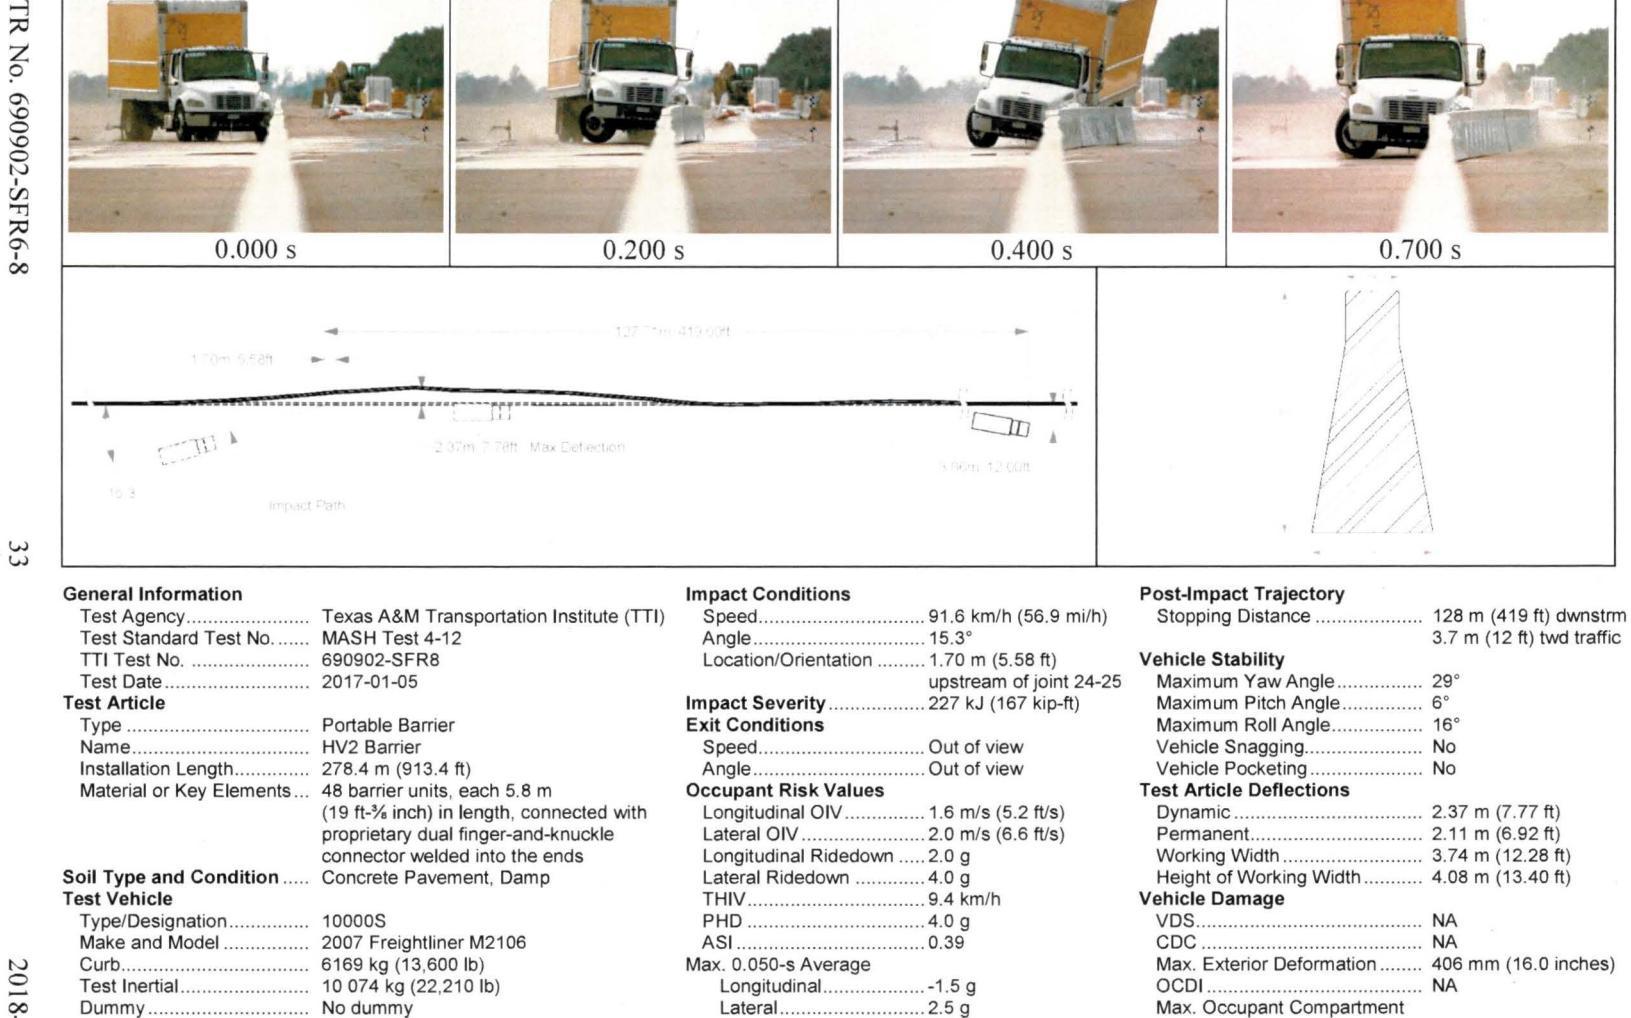
Figure 7.7. Summary of Results for MASH Test 4-12 on HV2 Barrier.

Gross Static ...... 10 074 kg (22,210 lb)

Vertical.....-3.1 g

Deformation..... None

4-12 (10000S)	MASH 4-12 (TTI) Test No. 690902-SFR8 Test Date - January 5th, 2018 Test Report No. 690902-SFR6,7&8 The test installation comprised of 48 connected, freestanding HV2 barriers, each 5.8m (19ft-3/8inch) long, totaling 278.4m (913ft-4.63inches). The 10,074kg (22,210lb) 2007 model Freightliner single-unit box-van truck was traveling at an impact speed of 91.6km/h (56.9mph) as it contacted the HV2 Barrier 1.70m (5.58ft) upstream of the joint between segments 24 and 25 at an impact angle of 15.3°. The HV2 Barrier contained and redirected the test vehicle with a Dynamic deflection of 2.37m (7.77ft). The vehicle did not penetrate, underride or override the installation. No detached elements, fragments, or other debris were present to penetrate or show potential for penetrating the occupant compartment, or to present undue hazard to others in the area. No occupant compartment deformation or intrusion occurred. The vehicle remained upright during and after the collision event. Maximum roll and pitch apagles ware 16° and 6° respectively.	PASS
