U.S. Department
of Transportation
**Federal Highway
Administration**

Name of system:	Armorwire
Type of system:	Cable Barrier with 3 or 4 Cable
Test Level:	NCHRP Report 350 TL-3 & TL-4
Testing conducted by:	Holmes Solutions Ltd (HSL)
Date of request:	December 15, 2010
Request initially acknowledged:	December 17, 2010
Task Force 13 Designator:	SGM33 a-b

Armowire TL-3 ,3 cable system

Armonwire TL-4, 4 cable system

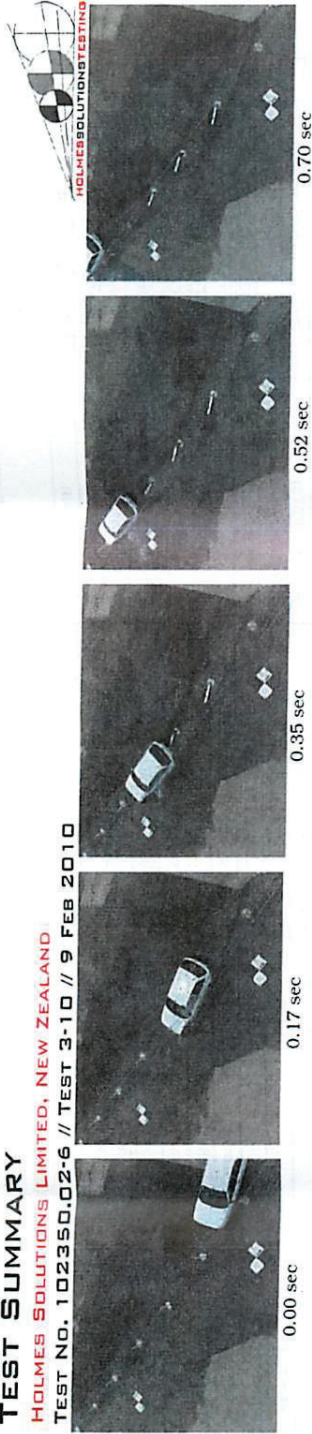
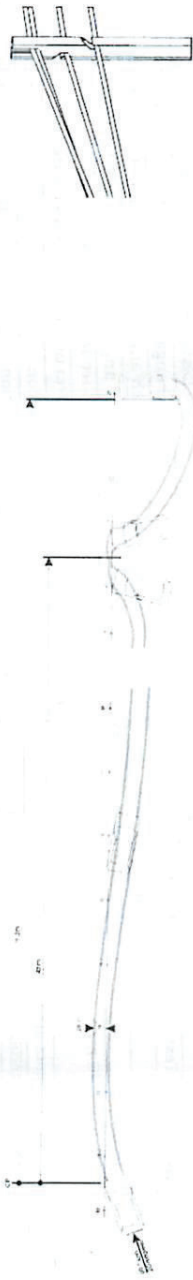
TEST NO. 102350.02-6 // TEST 3-10 // 9 FEB 2010

• TEST AGENCY	Holmes Solutions Ltd
• TEST NO.	102350.02-6 T3
• TEST DATE	9 February 2010
• TEST ARTICLE	4-wire rope barrier
• INSTALLATION LENGTH	118.9 M overall
• SOIL TYPE	AASHTO M 147-65 Standard soil
• KEY ELEMENTS - BARRIER	
Description.....	4-wire rope barrier with steel posts
Length	99 m LON
Post Spacing	3.0 metres
Wire Heights	530 / 650 / 770 / 790 mm
• TEST VEHICLE	
Designation.....	820C
Make/Model.....	Toyota Starlet
Dimensions (lwh).....	3700 x 1600 x 1340
Curb Wt.....	753 kg
Test Inertial Wt.....	834.5 kg
Gross Static Wt.....	911.5 kg
• IMPACT CONDITIONS	
Speed	99.7 kph
Angle	20 deg
Impact point	Midspan between posts 10 and 11
• EXIT CONDITIONS	
Exit speed	70.5 kph
Exit angle	11°

• OCCUPANT IMPACT VELOCITY (M/S)	
Longitudinal	3.5 m/s at 0.1613 s on right of interior
Lateral (optional).....	4.6 m/s at 0.1613 s
THIV (optional).....	5.2 m/s at 0.1570 s
• OCCUPANT RIDEDOWN ACCELERATION (G)	
x-direction.....	-7.0 g (0.1672 - 0.1772 s)
y-direction.....	-7.1g (0.2906 - 0.3006 s)
PHD (optional).....	8.2 g (0.1673 - 0.1773 s)
ASI (optional).....	0.60 (0.1269 0.1769 s)
• TEST ARTICLE DAMAGE	Moderate
• TEST ARTICLE DEFLECTIONS (M)	
Dynamic.....	1280 mm
Permanent.....	230 mm
• VEHICLE DAMAGE - EXTERIOR	
VDS	I1-LFQ-5
CDC	I1EYAW6
Maximum Deformation	120 mm
• VEHICLE DAMAGE - INTERIOR	
OCDI	LF0000100
• POST IMPACT VEHICLE BEHAVIOR	
Vehicle stability.....	Satisfactory
Stopping distance.....	51.7 metres
Max. roll angle	13.8° at 1.7587 s
Max. pitch angle	5.6° at 0.5590 s
Max. yaw angle	35.3° at 1.7790 s

- A. Test 4-10 was conducted with the 820C test vehicle on the 4 cable system which was 115 meters (377 feet) long including two 8 meters (26 feet) long Terminal Ends. The CIP was mid-span between posts 10 and 11, and the posts were installed on 3 meters (9.83 feet) centers in the impact area. The vehicle was smoothly re-directed by the barrier with all 4 cables remaining in contact with the impact side of the vehicle. The occupant risk values were all below the preferred limits. The dynamic deflection was 1280 millimeters (50.4 inches).

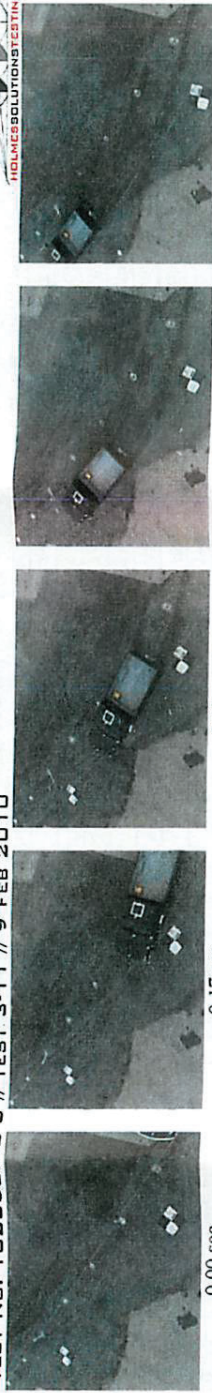
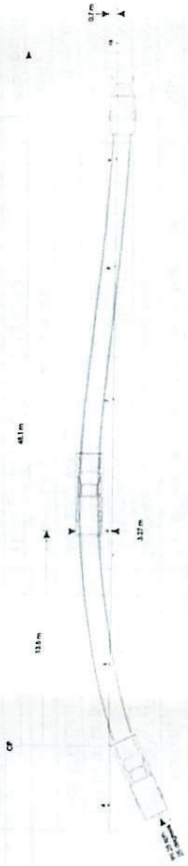
HOLMES SOLUTIONS LIMITED, NEW ZEALAND
 TEST NO. 102350.02-6 // TEST 3-11 // 9 FEB 2010

<ul style="list-style-type: none"> • TEST AGENCY Holmes Solutions Ltd • TEST NO. 102350.02-6 T4 • TEST DATE 9 February 2010 • TEST ARTICLE 3-wire rope barrier • INSTALLATION LENGTH 118.9 m overall • SOIL TYPE AASHTO M147-65 Standard soil • KEY ELEMENTS - BARRIER <ul style="list-style-type: none"> Description..... 3-wire rope barrier with steel posts Length 99 m LON Post Spacing 9.0 metres Wire Heights..... 530 / 650 / 770 mm • TEST VEHICLE <ul style="list-style-type: none"> Designation..... 2000P Make/Model..... Chevrolet C2500 Pick-up Dimensions (lwh)..... 5535 x 1940 x 1840 Curb Wt..... 1927 kg Test Inertial Wt..... 2001 kg Gross Static Wt..... 2001 kg • IMPACT CONDITIONS <ul style="list-style-type: none"> Speed 99.25 kph Angle 25 deg Impact point Midspan between posts 4 and 5 • EXIT CONDITIONS <ul style="list-style-type: none"> Exit speed Exit angle 	<ul style="list-style-type: none"> • OCCUPANT IMPACT VELOCITY (M/S) <ul style="list-style-type: none"> Longitudinal 1.7 m/sec at 0.22246 s on RS of Interior Lateral (optional) 3.2 m/sec THIV (optional) 3.5 m/sec at 0.2214 s on RS of Interior • OCCUPANT RIBEDOWN ACCELERATION (g) <ul style="list-style-type: none"> x-direction..... -4.0 g (0.4378 - 0.4478 sec) y-direction..... -4.8 g (0.3176 - 0.3276 sec) PHD (optional) 5.5 g (0.4041 - 0.4141 sec) ASI (optional) • TEST ARTICLE DAMAGE <ul style="list-style-type: none"> Dynamic..... Moderate Permanent..... 3270 mm • TEST ARTICLE DEFLECTIONS (M) <ul style="list-style-type: none"> Permanent..... 540 mm VDS 11-LFG-4 CDC 11LFEW3 Maximum Deformation 100 mm • VEHICLE DAMAGE - INTERIOR <ul style="list-style-type: none"> OCDI AS0000000 • POST IMPACT VEHICLE BEHAVIOR <ul style="list-style-type: none"> Vehicle stability..... Satisfactory Stopping distance..... 48.1 m Max. roll angle 8.1° at 1.1342 sec Max. pitch angle 4.4 ° at 8.1499 sec Max. yaw angle -25.5 ° at 2.2623 sec

- E. Test 3-11 was conducted with the 2000P truck a second time on the 3 cable system which was 115 meters (377feet) long including two 8 meters (26 feet) long Terminal Ends. The CIP was mid-span between posts 10 and 11, this time with the posts installed on 9 meters (29.5 feet) centers in the impact area. The vehicle was smoothly re-directed and captured by the barrier with

all 3 cables remaining in contact with the impact side of the vehicle. The occupant risk values were all below the preferred limits. The dynamic deflection was 3270 millimeters (128.7 inches).
