U.S. Department
of Transportation

Name of system: Universal TAU-M Crash Cushion (TAU-M) TL3

Type of system: Redirective, Non-Gating Crash Cushion

Test Level: MASH Test Level 3 (TL3)

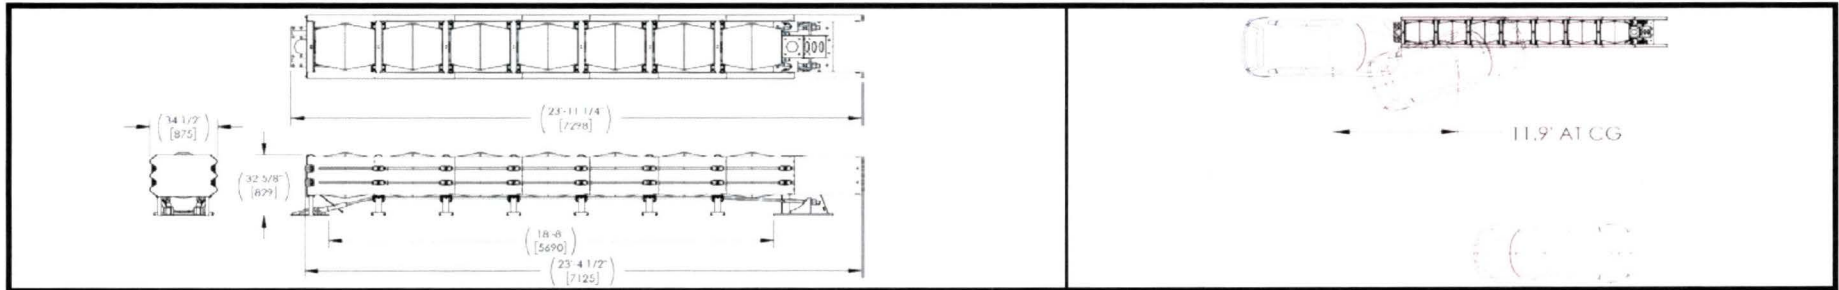
Test Agency..... **SAFE TECHNOLOGIES, INC.**
 Test Number..... TAU330-C1
 Test Designation MASH 3-30
 Date..... 1/2/2018

Name Universal TAU-M, TL-3
 Type Redirective, Non-gating Crash Cushion
 Installation Length 287 1/4 in (7.30 m)
 Width 34 1/2 in (875 mm)
 Height 32 5/8 in (829 mm)

Type / Designation 1100C
 Make and Model 2011 Hyundai Accent
 Curb Weight 2,460 lb (1,116 kg)
 Test Inertial Weight 2,427 lb (1,101 kg)
 Gross Static Weight 2,593 lb (1,176 kg)

Speed 61.8 mph (99.5 km/h)
 Angle 0.0 deg
 Location / Orientation 1/4 Offset

Vehicle Stability Satisfactory
 Longitudinal Stopping Distance (CG) 11.9 ft (3.62 m)
 Vehicle Snagging/Pocketing N/A

Longitudinal OIV 38.1 ft/s (11.6 m/s)
 Lateral OIV 1.64 ft/s (0.5 m/s)
 Longitudinal ORA 17.7 G
 Lateral ORA 4.8 G
 THIV 38.4 ft/s (11.7 m/s)
 PHD 17.8 G
 ASI 1.27

Longitudinal system stroke..... 8.05 ft (2.45 m)
 Permanent lateral deflection 6.0 in (15.2 cm)
 Dynamic lateral deflection 16.9 in (42.9 cm)

Required Test Number	Narrative Description	Evaluation Results
3-30 (1100C)	<p>The TAU-M was determined to have successfully met all of the evaluation criteria for MASH Test 3-30 for non-gating crash cushions.</p> <p>The TAU-M crash cushion satisfied the MASH structural adequacy criteria for its intended function as a non-gating crash cushion. The test article captured the 1100C vehicle in a controlled manner. The vehicle did not penetrate, underide, or override the installation. The test article exhibited controlled permanent and dynamic deflection in the test.</p> <p>All of the occupant risk criteria were satisfied in testing the TAU-M crash cushion. Theoretical OIVs in the longitudinal and lateral directions were below the limit of 40.0 ft/s (12.2 m/s). ORAs in the longitudinal and lateral directions were below the limit of 20.49 G. There was no test article debris detached during the test.</p> <p>There was minimal deformation to the occupant compartment of the 1100C test vehicle. There was no intrusion into the occupant compartment. The test vehicle remained upright during and after the collision with moderate roll and minor pitch.</p> <p>The TAU-M crash cushion was judged as satisfying the applicable MASH vehicle trajectory criteria.</p>	PASS

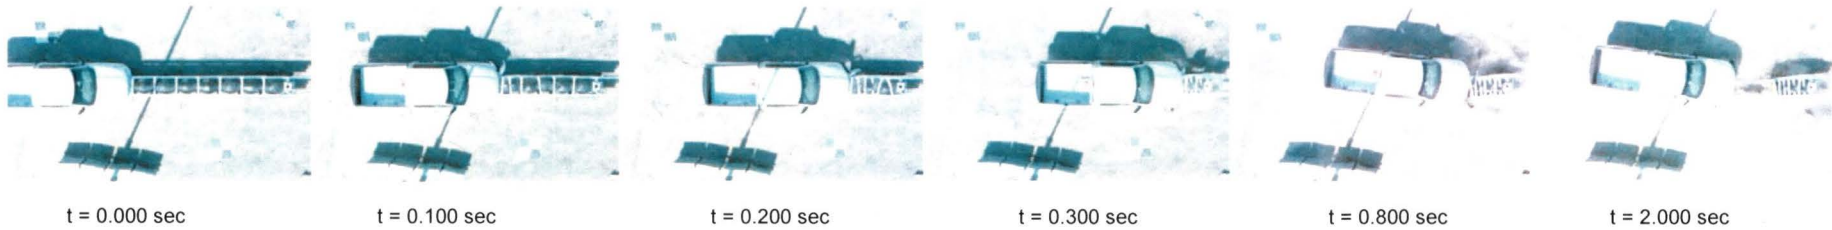
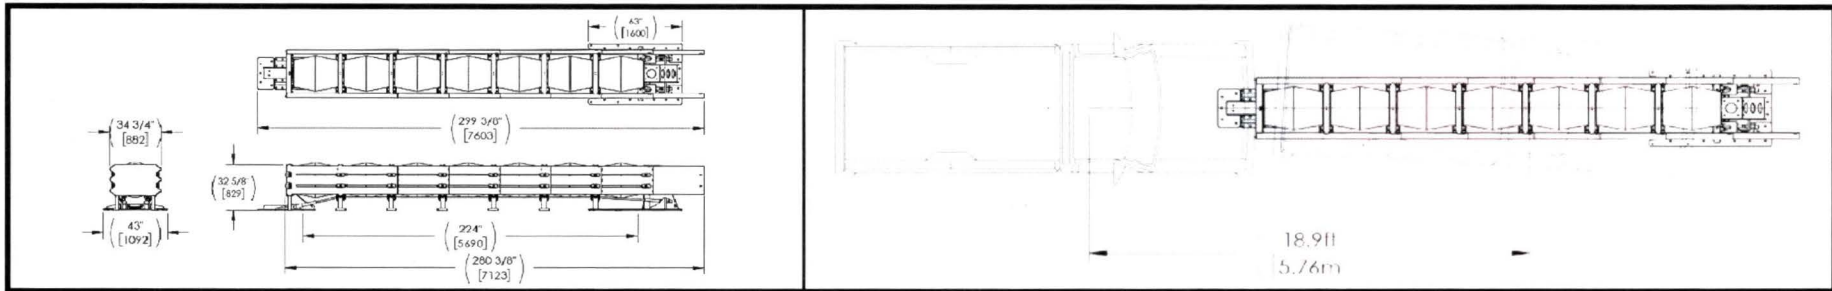
Test Agency..... **SAFE TECHNOLOGIES, INC.**
 Test Number..... TAU331A-C1
 Test Designation MASH 3-31
 Date..... 7/26/2018

Name Universal TAU-M, TL-3
 Type Redirective, Non-gating Crash Cushion
 Installation Length 299 3/8 in (7.60 m)
 Width 43 in (1.09 m)
 Height 32 5/8 in (829 mm)

Type / Designation 2270P
 Make and Model 2012 Dodge Ram 1500
 Curb Weight 4,917 lb (2,230.5 kg)
 Test Inertial Weight 5,025 lb (2,279.5 kg)
 Gross Static Weight 5,025 lb (2,279.5 kg)

Speed 62.5 mph (100.6 km/h)
 Angle 0.0 deg
 Location / Orientation Front/Center

Vehicle Stability Satisfactory
 Longitudinal Stopping Distance (CG) 18.9 ft (5.76 m)
 Vehicle Snagging/Pocketing N/A

Longitudinal OIV 28.5 ft/s (8.7 m/s)
 Lateral OIV 0.7 ft/s (0.2 m/s)
 Longitudinal ORA 13.8 G
 Lateral ORA 2.4 G
 THIV 28.5 ft/s (8.7 m/s)
 PHD 13.9 G
 ASI 1.06

Longitudinal System Stroke..... 15.0 ft (4.57 m)
 Permanent Lateral Deflection 5.2 in (13.2 cm)
 Dynamic Lateral Deflection 6.2 in (15.7 cm)

Required Test Number	Narrative Description	Evaluation Results
3-31 (2270P)	<p>Test 3-31 was performed on both Concrete and Asphalt configurations:</p> <p>In each test, the TAU-M was determined to have successfully met all of the evaluation criteria for MASH Test 3-31 for non-gating crash cushions in both the Concrete and Asphalt configurations.</p> <p>In each test, the TAU-M crash cushion satisfied the MASH structural adequacy criteria for its intended function as a non-gating crash cushion. The test article captured the 2270P vehicle in a controlled manner. The vehicle did not penetrate, underride or override the installation. The test article exhibited controlled permanent and dynamic deflection in each test.</p> <p>All of the occupant risk criteria were satisfied in testing the TAU-M crash cushion. Theoretical OIVs in the longitudinal and lateral directions were below the preferred limit of 30.0 ft/s (9.1 m/s). ORAs in the longitudinal and lateral directions were below the limit of 20.49 G. In the Asphalt configuration, the ORAs in the longitudinal and lateral directions were below the preferred limit of 15.0 G. There was no test article debris detached during the test.</p> <p>In each test, there was no deformation in the occupant compartment of the 2270P test vehicle. There was no intrusion into the occupant compartment. The test vehicle remained upright during and after the collision with minor roll and pitch.</p> <p>The TAU-M crash cushion was judged as satisfying the applicable MASH vehicle trajectory criteria for both Concrete and Asphalt configurations.</p>	PASS

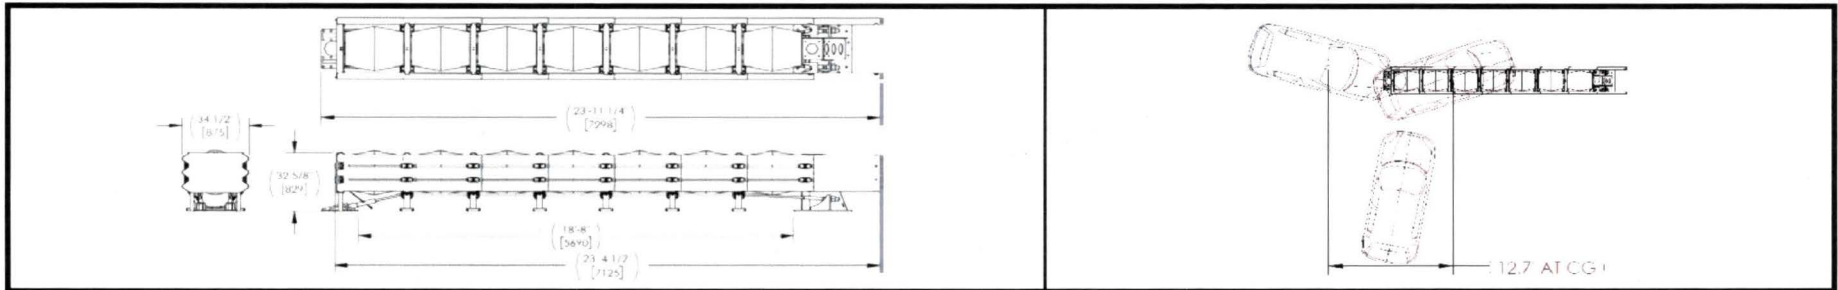
Test Agency..... **SAFE TECHNOLOGIES, INC.**
 Test Number..... TAU332-C2
 Test Designation MASH 3-32
 Date..... 4/26/2018

Name Universal TAU-M, TL-3
 Type Redirective, Non-gating Crash Cushion
 Installation Length 287 1/4 in (7.30 m)
 Width 34 1/2 in (875 mm)
 Height 32 5/8 in (829 mm)

Type / Designation 1100C
 Make and Model 2011 Hyundai Accent
 Curb Weight 2,434 lb (1,104 kg)
 Test Inertial Weight 2,447 lb (1,110 kg)
 Gross Static Weight 2,615 lb (1,186 kg)

Speed 62.6 mph (100.8 km/h)
 Angle 15 deg
 Location / Orientation Front/Center

Vehicle Stability Satisfactory
 Longitudinal Stopping Distance (CG) 12.7 ft (3.87 m)
 Vehicle Snagging/Pocketing N/A

Longitudinal OIV 40.0 ft/s (12.2 m/s)
 Lateral OIV 3.61 ft/s (1.1 m/s)
 Longitudinal ORA 11.8 G
 Lateral ORA 3.1 G
 THIV 40.7 ft/s (12.4 m/s)
 PHD 12.1 G
 ASI 1.37

Longitudinal system stroke..... 10.2 ft (3.10 m)
 Permanent lateral deflection 10.8 in (27.4 cm)
 Dynamic lateral deflection 17.9 in (45.4 cm)

3-32 (1100C)	<p>The TAU-M was determined to have successfully met all of the evaluation criteria for MASH Test 3-32 for non-gating crash cushions.</p> <p>The TAU-M crash cushion satisfied the MASH structural adequacy criteria for its intended function as a non-gating crash cushion. The test article captured the 1100C vehicle in a controlled manner. The vehicle did not penetrate, underride or override the installation. The test article exhibited controlled permanent and dynamic deflection in the test.</p> <p>All of the occupant risk criteria were satisfied in testing the TAU-M crash cushion. Theoretical OIVs in the longitudinal and lateral directions were at or below the limit of 40.0 ft/s (12.2 m/s). ORAs in the longitudinal and lateral directions were below the preferred limit of 15.0 G. There was no test article debris detached during the test.</p> <p>There was minimal deformation in the occupant compartment of the 1100C test vehicle. There was no intrusion into the occupant compartment. The test vehicle remained upright during and after the collision with minor roll and moderate pitch.</p> <p>The TAU-M crash cushion was judged as satisfying the applicable MASH vehicle trajectory criteria.</p>	PASS

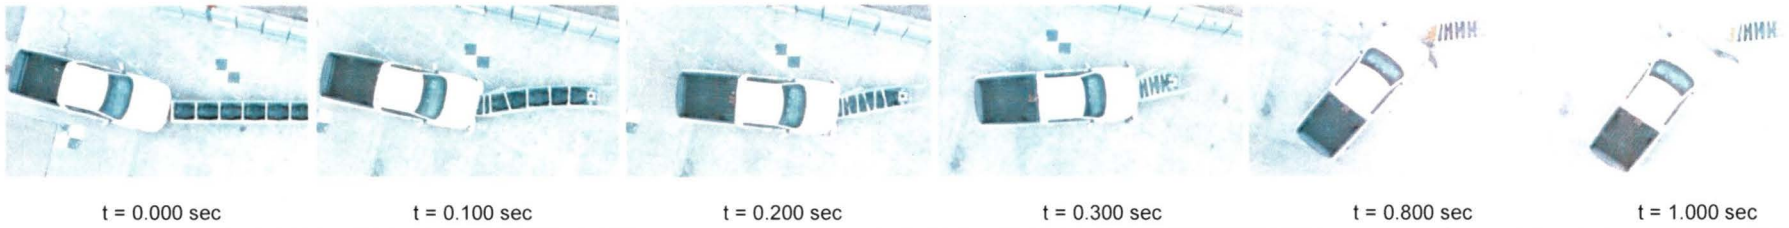
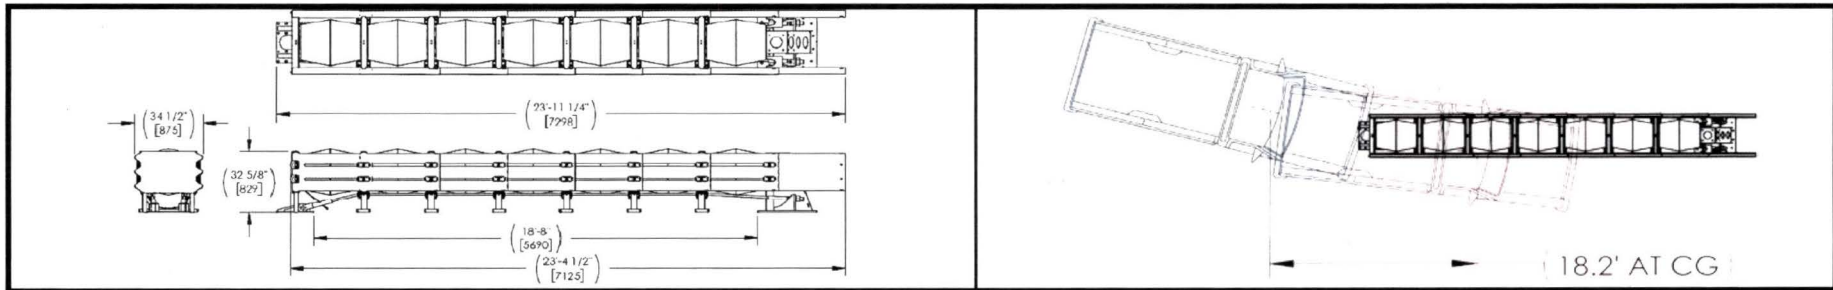
Test Agency..... **SAFE TECHNOLOGIES, INC.**
 Test Number..... TAU333-C1
 Test Designation MASH 3-33
 Date..... 5/25/2018

Name Universal TAU-M, TL-3
 Type Redirective, Non-gating Crash Cushion
 Installation Length 287 1/4 in (7.30 m)
 Width 34 1/2 in (875 mm)
 Height 32 5/8 in (829 mm)

Type / Designation 2270P
 Make and Model 2012 Dodge Ram 1500
 Curb Weight 5,027 lb (2,280 kg)
 Test Inertial Weight 4,984 lb (2,260.5 kg)
 Gross Static Weight 4,984 lb (2,260.5 kg)

Speed 62.6 mph (100.8 km/h)
 Angle 15 deg
 Location / Orientation Front/Center

Vehicle Stability Satisfactory
 Longitudinal Stopping Distance (CG) 18.2 ft (5.53 m)
 Vehicle Snagging/Pocketing N/A

Longitudinal OIV 29.9 ft/s (9.1 m/s)
 Lateral OIV 2.30 ft/s (0.7 m/s)
 Longitudinal ORA 15.3 G
 Lateral ORA 2.9 G
 THIV 30.2 ft/s (9.2 m/s)
 PHD 15.4 G
 ASI 1.04

Longitudinal System Stroke..... 15.3 ft (4.7 m)
 Permanent Lateral Deflection 7.3 in (18.6 cm)
 Dynamic Lateral Deflection 17.7 in (45.0 cm)

3-33 (2270P)	<p>The TAU-M was determined to have successfully met all of the evaluation criteria for MASH Test 3-33 for non-gating crash cushions.</p> <p>The TAU-M crash cushion satisfied the MASH structural adequacy criteria for its intended function as a non-gating crash cushion. The test article captured the 2270P vehicle in a controlled manner. The vehicle did not penetrate, underide, or override the installation. The test article exhibited controlled permanent and dynamic deflection in the test.</p> <p>All of the occupant risk criteria were satisfied in testing the TAU-M crash cushion. Theoretical OIVs in the longitudinal and lateral directions were at or below the preferred limit of 30 ft/s (9.1 m/s). ORAs in the longitudinal and lateral directions were below the limit of 20.49 G. There was no test article debris detached during the test.</p> <p>There was minimal deformation in the occupant compartment of the 2270P test vehicle. There was no intrusion into the occupant compartment. The test vehicle remained upright during and after the collision with minor roll and pitch.</p> <p>The TAU-M crash cushion was judged as satisfying the applicable MASH vehicle trajectory criteria.</p>	PASS

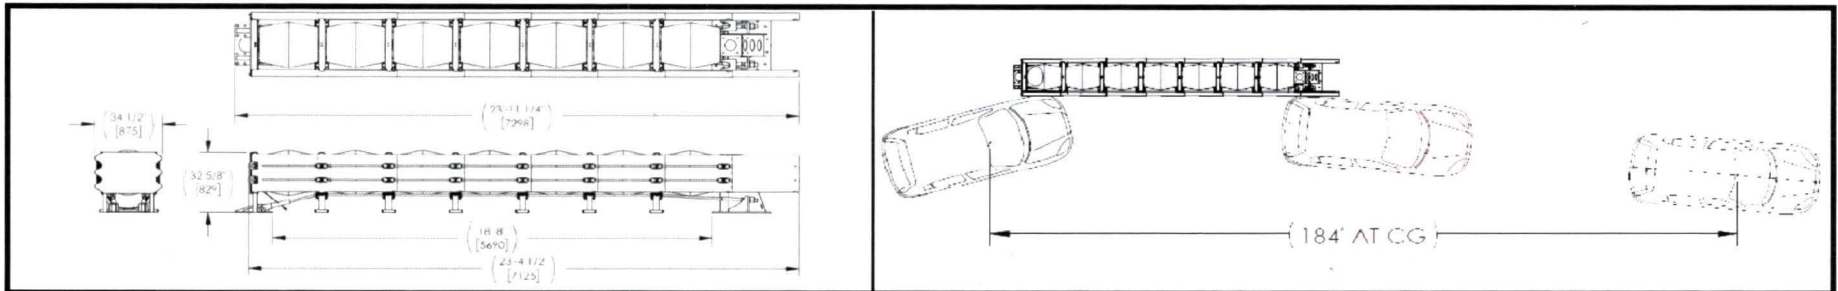
Test Agency..... **SAFE TECHNOLOGIES, INC.**
 Test Number..... TAU334-C1
 Test Designation MASH 3-34
 Date..... 5/4/2018

Name Universal TAU-M, TL-3
 Type Redirective, Non-gating Crash Cushion
 Installation Length 287 1/4 in (7.30 m)
 Width 34 1/2 in (875 mm)
 Height 32 5/8 in (829 mm)

Type / Designation 1100C
 Make and Model 2011 Kia Rio
 Curb Weight 2,462 lb (1,116.5 kg)
 Test Inertial Weight 2,454 lb (1,113 kg)
 Gross Static Weight 2,619 lb (1,188 kg)

Speed 62.9 mph (101.3 km/h)
 Angle 15.0 deg
 Location / Orientation CIP, 2.5 ft (76.4 cm) downstream from upstream end

Speed..... 57 mph (92.4 km/h)
 Angle..... 20 deg

Vehicle Stability Satisfactory
 Longitudinal Stopping Distance (CG) 184 ft (56.1 m)
 Vehicle Snagging/Pocketing None

Longitudinal OIV 6.6 ft/s (2.0 m/s)
 Lateral OIV 16.1 ft/s (4.9 m/s)
 Longitudinal ORA 3.7 G
 Lateral ORA 10.5 G
 THIV 17.7 ft/s (5.4 m/s)
 PHD 10.6 G
 ASI 0.82

Longitudinal System Stroke..... N/A
 Permanent Lateral Deflection 1.6 in (3.9 cm)
 Dynamic Lateral Deflection 10.1 in (25.5 cm)

3-34 (1100C)	<p>The TAU-M was determined to have successfully met all of the evaluation criteria for MASH Test 3-34 for non-gating crash cushions.</p> <p>The TAU-M crash cushion satisfied the MASH structural adequacy criteria for its intended function as a non-gating crash cushion. The test article first captured and later redirected the 1100C vehicle in a controlled manner. The vehicle did not penetrate, underride, or override the installation. The test article exhibited some permanent and dynamic deflection in the test.</p> <p>All of the occupant risk criteria were satisfied in testing the TAU-M crash cushion. Theoretical OIVs in the longitudinal and lateral directions were well below the preferred limit of 30.0 ft/s (9.1 m/s). ORAs in the longitudinal and lateral directions were below the preferred limit of 15.0 G. There was no test article debris detached during the test.</p> <p>There was minimal deformation to the occupant compartment of the 1100C test vehicle. There was no intrusion into the occupant compartment. The test vehicle remained upright during and after the collision with minor roll and pitch.</p> <p>The TAU-M crash cushion was judged as satisfying the applicable MASH vehicle trajectory criteria.</p>	PASS

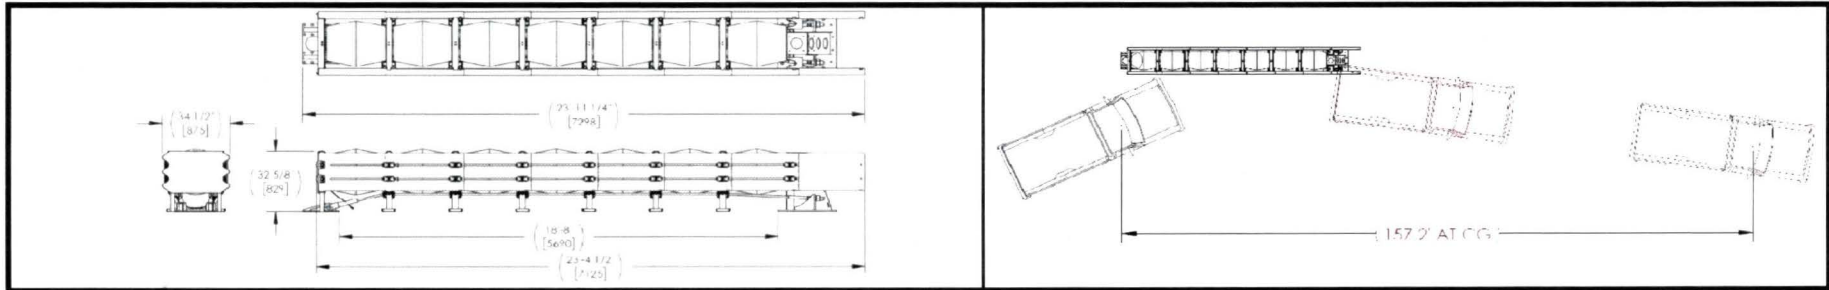
Test Agency..... **SAFE TECHNOLOGIES, INC.**
 Test Number..... TAU335-C1
 Test Designation MASH 3-35
 Date..... 5/2/2018

Name Universal TAU-II-M, TL-3
 Type Redirective, Non-gating Crash Cushion
 Installation Length 287 1/4 in (7.30 m)
 Width 34 1/2 in (875 mm)
 Height 32 5/8 in (829 mm)

Type / Designation 2270P
 Make and Model 2011 Dodge Ram 1500
 Curb Weight 4,730 lb (2,145.5 kg)
 Test Inertial Weight 5,045 lb (2,288.5 kg)
 Gross Static Weight 5,045 lb (2,288.5 kg)

Speed 63.3 mph (101.9 km/h)
 Angle 25 deg
 Location / Orientation CIP at 3.9 ft (1.2 m) downstream from upstream end of right panel 1

Speed..... 53.6 mph (86.3 km/h)
 Angle..... 9 deg

Vehicle Stability Satisfactory
 Longitudinal Stopping Distance (CG) 157.2 ft (47.9 m)
 Vehicle Snagging/Pocketing Minimal

Longitudinal OIV 13.8 ft/s (4.2 m/s)
 Lateral OIV 20.3 ft/s (6.2 m/s)
 Longitudinal ORA 9.2 G
 Lateral ORA 11.1 G
 THIV 23.3 ft/s (7.1 m/s)
 PHD 13.5 G
 ASI 1.19

3-35 (2270P)	<p>The TAU-M was determined to have successfully met all of the evaluation criteria for MASH Test 3-35 for non-gating crash cushions.</p> <p>The TAU-M crash cushion satisfied the MASH structural adequacy criteria for its intended function as a non-gating crash cushion. The test article first captured and later redirected the 2270P vehicle in a controlled manner. The vehicle did not penetrate, underride, or override the installation. The test article exhibited controlled permanent and dynamic deflection in the test.</p> <p>All of the occupant risk criteria were satisfied in testing the TAU-M crash cushion. Theoretical OIVs in the longitudinal and lateral directions were well below the preferred limit of 30.0 ft/s (9.1 m/s). ORAs in the longitudinal and lateral directions were below the preferred limit of 15.0 G. There was no test article debris detached during the test.</p> <p>There was minimal deformation to the occupant compartment of the 2270P test vehicle. There was no intrusion into the occupant compartment. The test vehicle remained upright during and after the collision with moderate roll and minor pitch.</p> <p>The TAU-M crash cushion was judged as satisfying the applicable MASH vehicle trajectory criteria.</p>	PASS

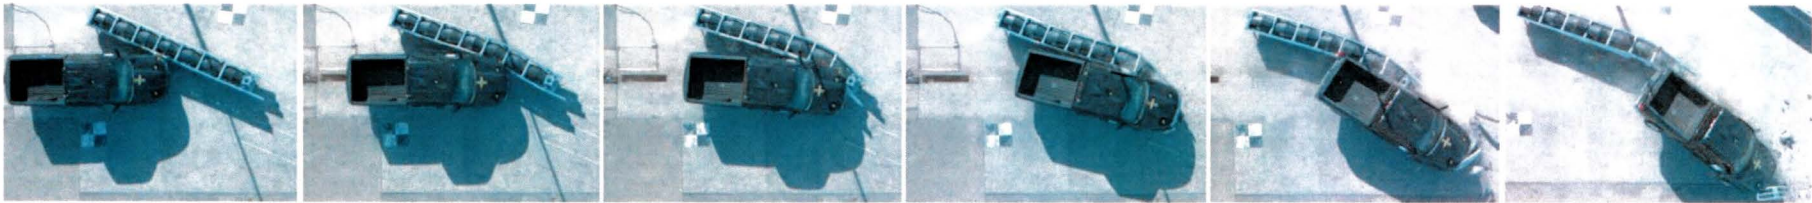
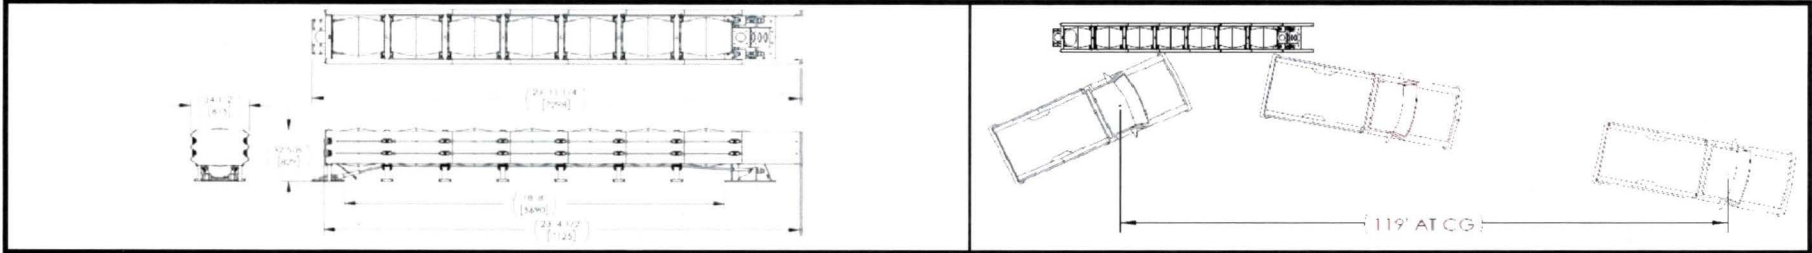
Test Agency.....SAFE TECHNOLOGIES, INC.
 Test Number.....TAU336-C1
 Test Designation.....MASH 3-36
 Date.....12/18/2017

Moderate

VDS.....11-LFQ-6
 CDC.....11LFES3
 Maximum Deformation.....4.6 in (117 mm)-toe pan area

3-36 (2270P)	<p>Test 3-36 was performed on both Concrete and Asphalt configurations:</p> <p>In each configuration, the TAU-M was determined to have successfully met all of the evaluation criteria for MASH Test 3-36 for non-gating crash cushions.</p> <p>In each configuration, the TAU-M crash cushion satisfied the MASH structural adequacy criteria for its intended function as a non-gating crash cushion. The test article first captured and later redirected the 2270P vehicle in a controlled manner. The vehicle did not penetrate, underide, or override the installation. The test article exhibited controlled permanent and dynamic deflection in each test.</p> <p>In each configuration, all of the occupant risk criteria were satisfied in testing the TAU-M crash cushion. Theoretical OIVs in the longitudinal and lateral directions were below the preferred limit of 30.0 ft/s (9.1 m/s). ORAs in the longitudinal and lateral directions were below or at the preferred limit of 15.0 G. There was no test article debris detached during the test.</p> <p>In each configuration, there was moderate deformation to the occupant compartment of the 2270P test vehicle. There was no intrusion into the occupant compartment. The test vehicle remained upright during and after the collision with moderate roll and minor pitch.</p> <p>The TAU-M crash cushion was judged as satisfying the applicable MASH vehicle trajectory criteria for both Concrete and Asphalt configurations.</p>	PASS

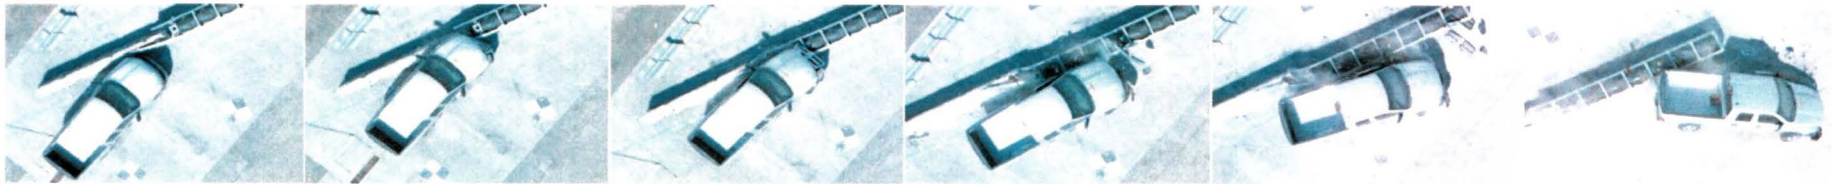
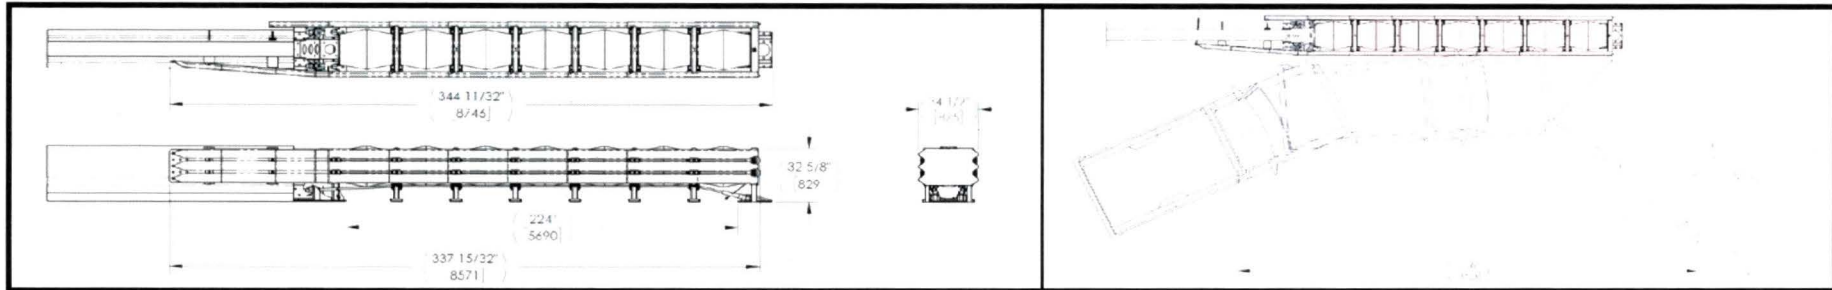
Test Agency..... **SAFE TECHNOLOGIES, INC.**
 Test Number..... TAU337a-C1
 Test Designation MASH 3-37a
 Date..... 5/22/2018

Test Article Damage:..... Minimal

VDS..... 11-LFQ-6
 CDC..... 11LDEW2
 Maximum Interior Deformation 7.5 in (191 mm),

3-37 (2270P)	<p>The TAU-M was determined to have successfully met all of the evaluation criteria for MASH Test 3-37a for non-gating crash cushions.</p> <p>The TAU-M crash cushion satisfied the MASH structural adequacy criteria for its intended function as a non-gating crash cushion. The test article first captured and later redirected the 2270P vehicle in a controlled manner. The vehicle did not penetrate, underide, or override the installation. The test article exhibited controlled permanent and dynamic deflection in the test.</p> <p>All of the occupant risk criteria were satisfied in testing the TAU-M crash cushion. Theoretical OIVs in the longitudinal and lateral directions were below the limit of 40.0 ft/s (12.2 m/s). ORAs in the longitudinal and lateral directions were below the limit of 20.49 G. There were some detached fragments of a blockout that landed in the near vicinity of the backstop, which did not pose a threat to the occupant compartment, other vehicles, pedestrians or personnel in a work zone.</p> <p>There was moderate deformation to the occupant compartment of the 2270P test vehicle. There was no intrusion into the occupant compartment. The test vehicle remained upright during and after the collision with moderate roll and minor pitch.</p> <p>The TAU-M crash cushion was judged as satisfying the applicable MASH vehicle trajectory criteria.</p>	PASS

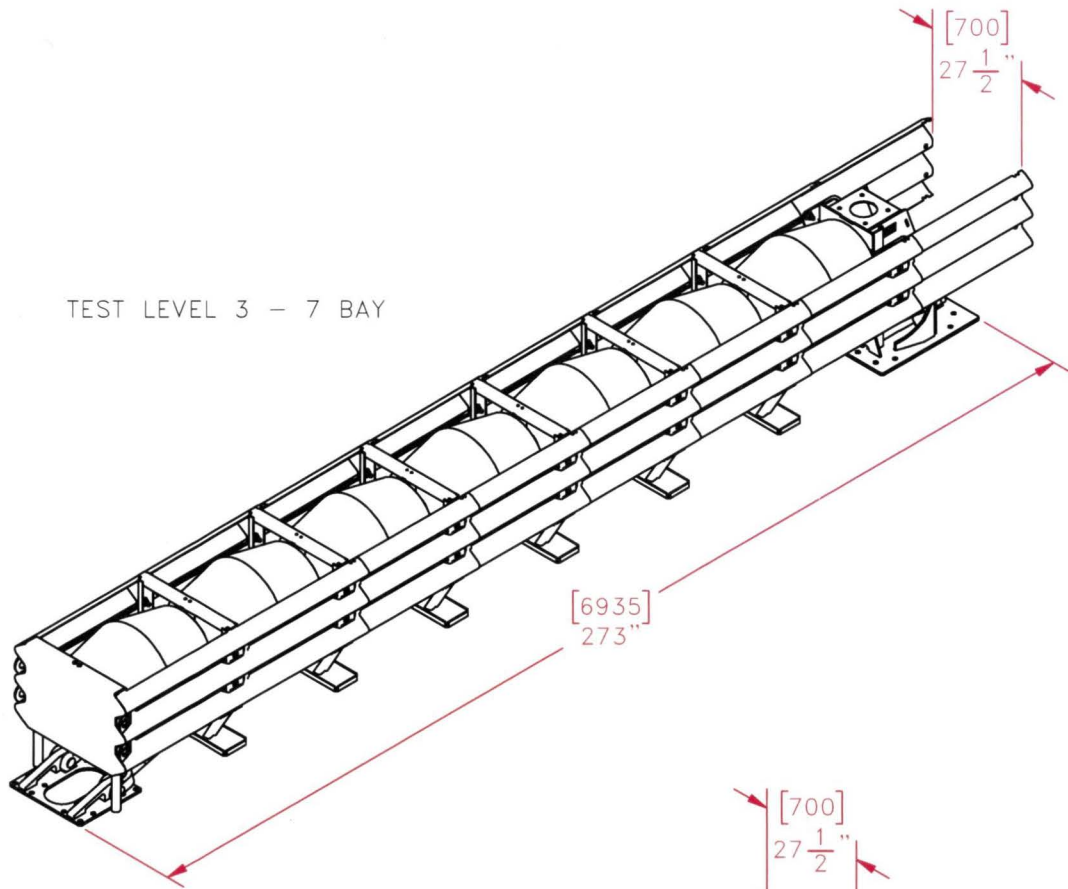
TEST LEVEL 3 - 7 BAY

The Universal TAU-M™ parallel crash cushions can protect hazards up to 30" [762] and offers a variety of anchoring options to fit many applications. Standard non-proprietary three-beam transitions may enable protecting much wider hazards. Test Level 2 systems are 4 Bays and Test Level 3 systems are 7 Bays.

The Universal TAU-M™ Parallel (TAU-M) is a redirective, non-gating crash cushion designed to meet the latest test standards defined in the Manual for Assessing Safety Hardware (MASH), Second Edition, 2016. The TAU-M system utilizes a cable anchoring system, telescoping thrie-beam panels, and energy absorbing cartridges (EAC) to absorb kinetic energy and safely contain or redirect impacting vehicles. The system is comprised of EACs, cables, a front cable anchor, a backstop, four end panel mounts, middle support assemblies (midsupports), cable guides, a front support, a front support leg kit, sliding panels, two end panels, slider kits, slider shims, a tether kit, four tow hooks, and a delineation bracket. The system has a nominal 32 5/8" height and 34 1/2" width. The test level 3 system measures approximately 287" (7 Bays) in length.
